BLM-Alaska Open File Report 64  
BLM/AK/ST-97/022+8111+040  
April 1997

# HISTORIC BUILDING SURVEY REPORT FLAT, ALASKA

by Rolfe G. Buzzell and Darrel L. Lewis

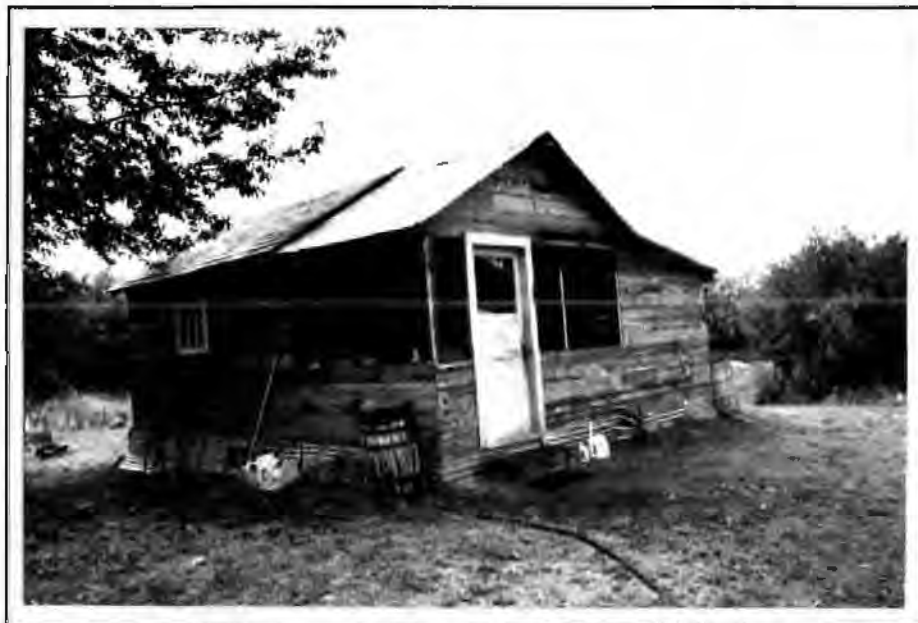
The Parker/Miller/Kepler Guesthouse (IDT-127) is a rectangular, one-story, wood frame building with two additions and a porch (Figure 94). The foundation of the house and additions is concrete blocks on grade. The gable roof is covered with shingles and corrugated metal. The building measures 12'x16'. Shiplap covers the exterior walls of the house and additions. The main entry is on the north elevation, which includes a one-panel door with a single-light and a six-light, fixed sash window. A gable roof porch covers the north elevation. The porch measures 8'1"x12' and the gable roof is covered with corrugated metal. The lower part of the porch is sided with shiplap and the upper portion is screened in. A three-panel door with one-light faces north. The east elevation of the house has a six-light, fixed sash window. The south elevation has a decorative four-light, fixed sash window. The fourth light has ten diamond lights. A shed addition on the west side of the house measures 8'2"x24'. The roof is covered with corrugated metal and roofing felt. A six-light, fixed sash window faces west and a three-panel door with one-light and a boarded over window face south. A small shed roof arctic entry covers the south elevation of the addition. The arctic entry measures 4'5"x8'2" and the shed roof is covered with corrugated metal. A three-panel door with one-light faces south.

Figure 94. The Parker/Miller/Kepler Guesthouse, 1993. The view is looking southwest.

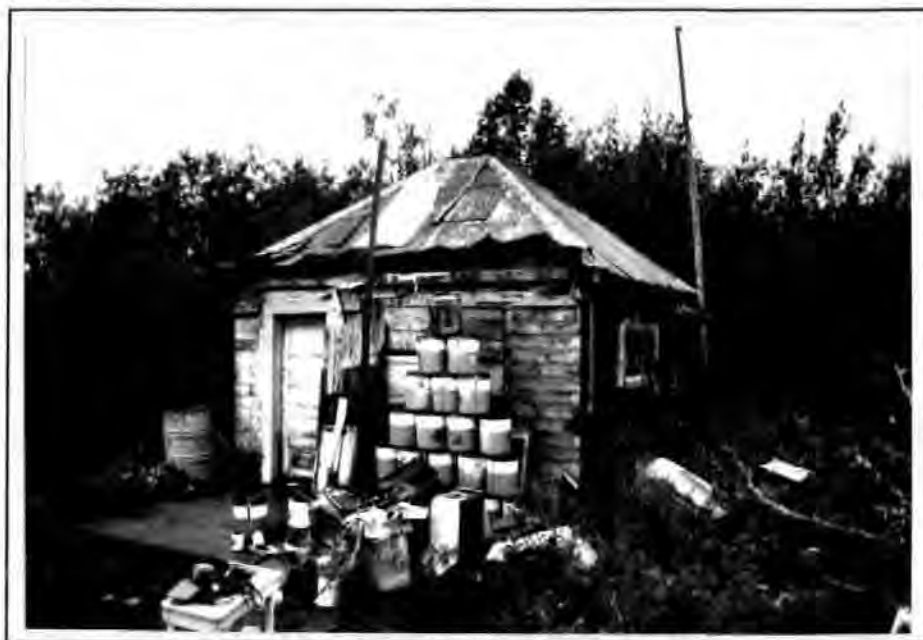
The **Finn Annie/Burns House (IDT-128)** is a square, one-story, wood frame building (Figure 95). The foundation consists of wood beams on grade. Corrugated metal covers the hipped roof. The building measures 14'3" per side. The exterior walls are covered with shiplap and roofing felt. The main entry is on the east elevation, which has a five-panel door and a boarded up window. A pair of single-light, fixed sash windows are located on the north elevation. A three-light, fixed sash window is located on the west elevation. An open porch measuring 4'5"x14'3"

is located on the east side of the house. This deck is made of tongue and groove flooring. A 55 gallon barrel, about 20 round metal fuel cans, and a number of boxes are stacked on the deck. A snow machine, a stove, stove pipe, window frames, and various domestic items are located outside of the building. A large cleared area measuring 70'x70' is located south and east of the building.

Figure 95. The Finn Annie/Burns House, 1993. The view is looking southwest.

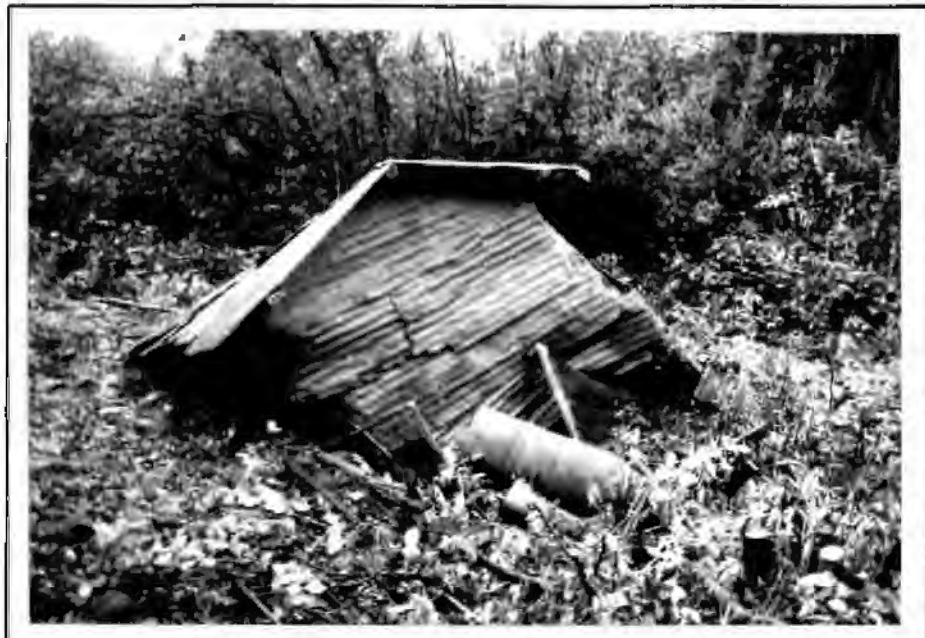
**The Anderson Shed Ruins (IDT-129)** are located about 100' northwest of the Finn Annie/Burns House. The feature consists of the ruins of a rectangular, one-story, log frame structure (Figure 96). The structure was elevated 4' on poles and access was by ladder (Agoff 1995:239). Corrugated metal covers the gable roof and exterior walls. The building measures 7'6"x7'10". The building collapsed on to the north and east walls. The roof

**Figure 96. The Anderson Shed ruins, 1993. The view is looking southeast.**

and south and west walls are still nominally intact. Artifacts around the building ruins include a 55 gallon metal barrel, a bed frame and mattress, a suit case, and shoes.

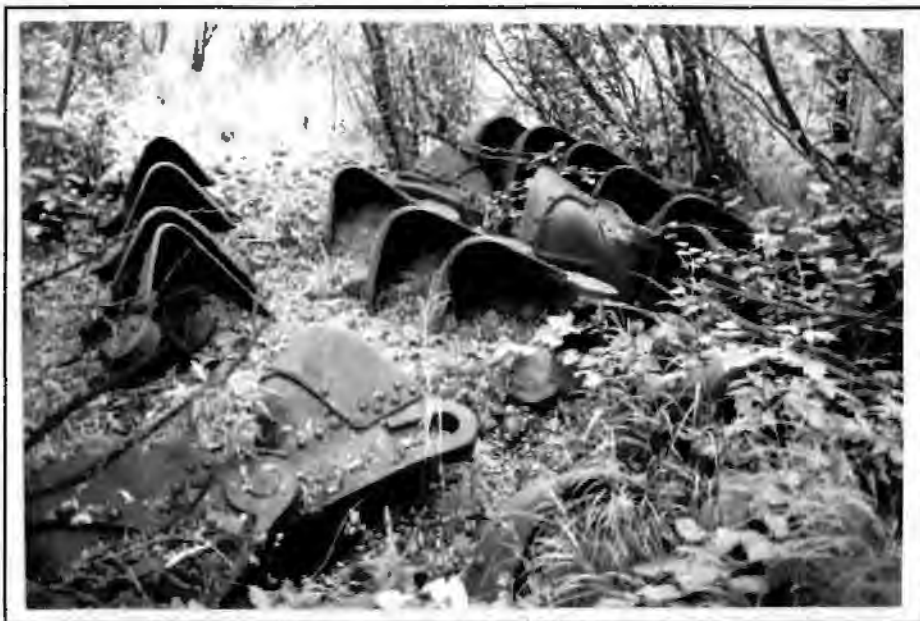
The **Guggenheim Dredge Bucket Line (IDT-236)** consists of 25-30 cast iron dredge buckets (Figure 97). The buckets are located in an area measuring 20'x50'. Each bucket held six cubic feet of material. The feature consists of lines of four to six attached buckets and single buckets in a confined area.

**Figure 97. The Guggenheim Dredge Buckets, 1993. The view is looking south.**

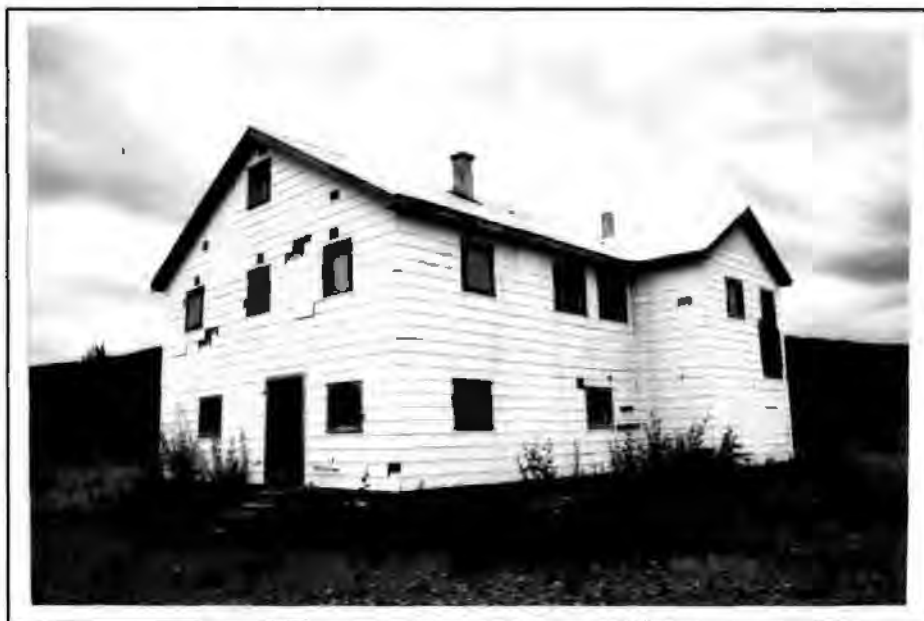
The **Signal Corps Building (IDT-130)** is a modified rectangular, 2.5 story, wood frame building (Figure 98). The foundation consists of wood blocks, logs, and metal barrels on grade. Corrugated metal covers the gable roof. The building measures 29'4"x45'11". The exterior walls are covered with asbestos shingles. The main entry is on the east elevation, which has a three-panel door, a six-light, fixed sash window, and a gable roof arctic entry on the first floor. The arctic entry has a boarded up panel door facing east. The second floor has three single-light, fixed sash windows and a single-light, fixed sash window in the gable. Two six-light, fixed sash windows are located on the first floor of the south elevation. Four single-light, fixed

sash windows are located on the second floor. A two-story addition with a gable roof is located towards the east end of the south elevation. The second floor level of the addition has a single-light, fixed sash window and a three-panel door. There is no outside stairway access to this door. The first floor of the west elevation has a diagonal shiplap door flanked on each side by a six-light, fixed sash window. Three

**Figure 98. The Signal Corps Building, 1993. The view is looking northeast.**

single-light, fixed sash windows are evenly spaced on the second floor and a single-light, fixed sash window is centered in the gable. The north elevation has a six-light, fixed sash window on the first floor. The second floor has a pair of 1/1 single-hung windows and a six-light, fixed sash window. A two-story gable roof addition is located at the east end of the north elevation. The ground floor of the addition has a single-light, fixed sash window. The second floor has a boarded up window and a single-light, fixed sash window.

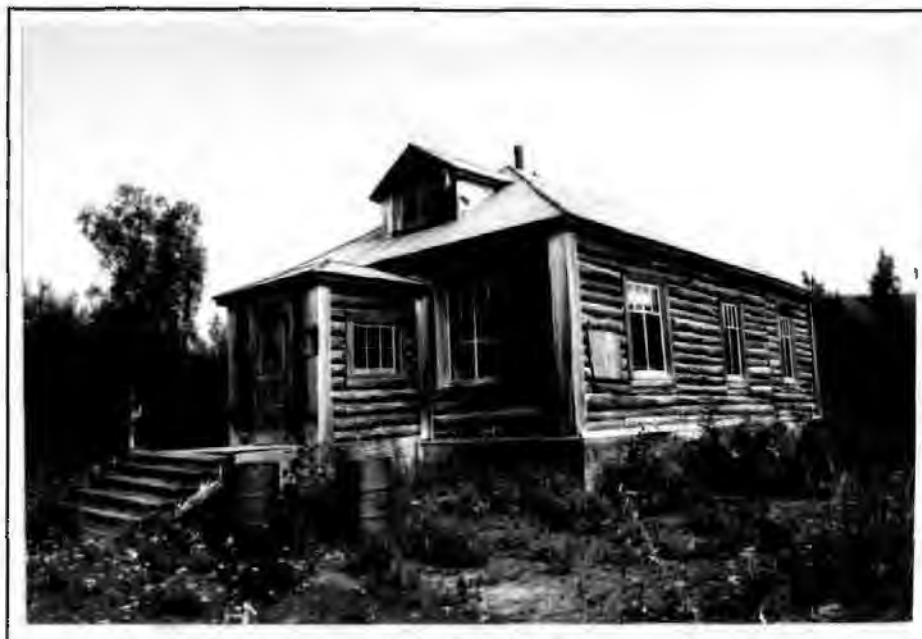
The Shaffrick House (IDT-145) is a rectangular, 1.5 story, log building (Figure 100). The foundation consists of vertical posts on grade. Corrugated

**Figure 100. The Shaffrick House, 1993.**  
The view is looking northwest.

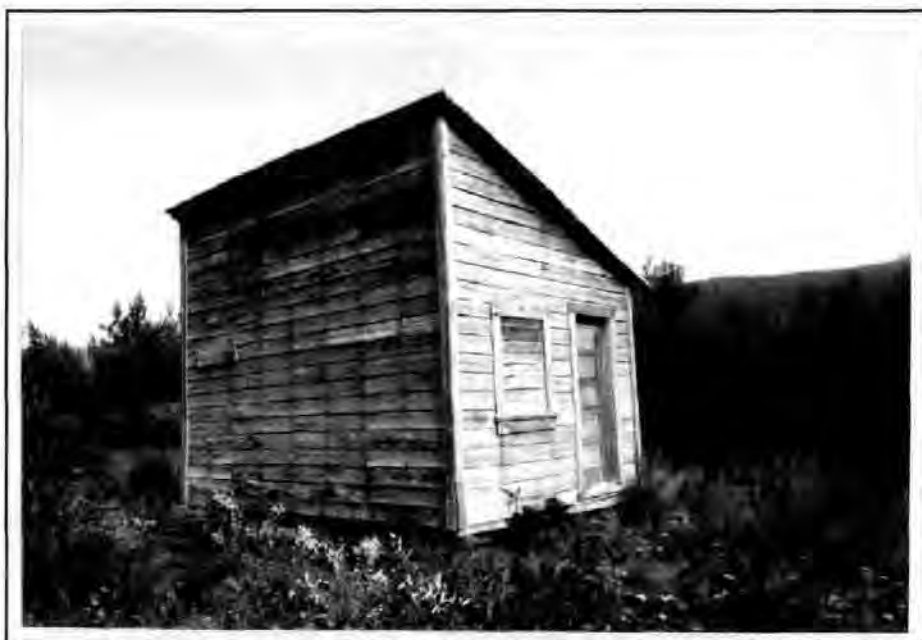
The **Shaffrick Power Shed (IDT-146)** is a rectangular, one-story, wood frame building (Figure 101) located 108' northeast of the Shaffrick House. The foundation is logs on blocks. Corrugated metal covers the shed roof. The shed measures 12'4"x16'4" and the exterior walls are covered with wood siding and corner boards. A five-panel door and a boarded up window are located on the east elevation.

**Figure 101. The Shaffrick Power Shed, 1993.**  
The view is looking northwest.

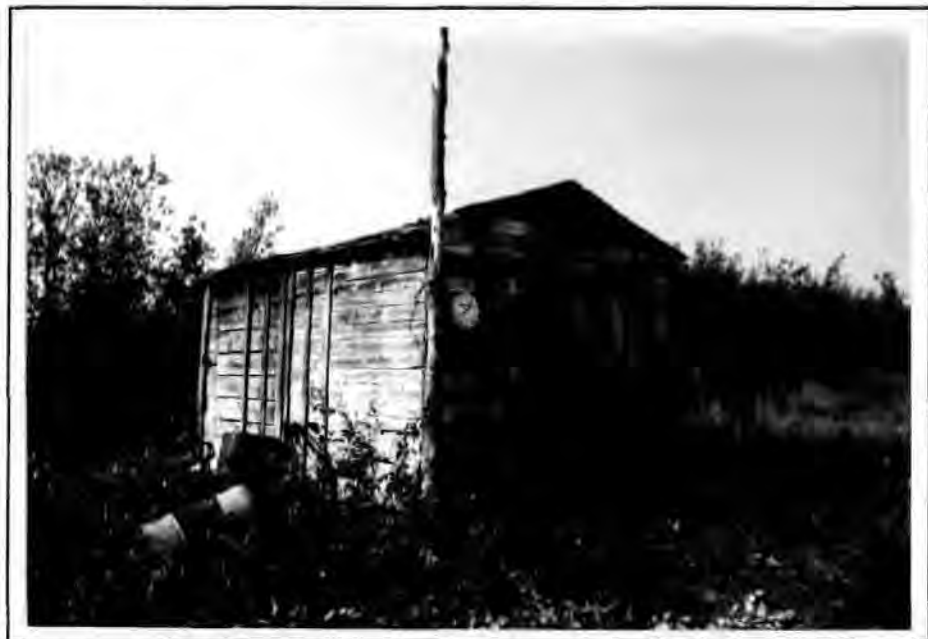
The **Airstrip Storage Shed (IDT-147)** is a rectangular, one-story, wood frame building (Figure 102). The foundation is on grade. Corrugated metal covers the gable roof. The building measures 12'2"x14'2". The exterior walls are covered with weather stripped roofing felt over horizontal wood siding. The main entry is on the north elevation, which has a large plank door. Two six-light, fixed sash windows are evenly spaced on the west elevation. A six-light, fixed sash window is located on the east end of the south elevation. A tall pole with a weather vane on top is attached to the north-east corner of the building.

**Figure 102. The Airstrip Storage Shed, 1993. The view is looking southwest.**

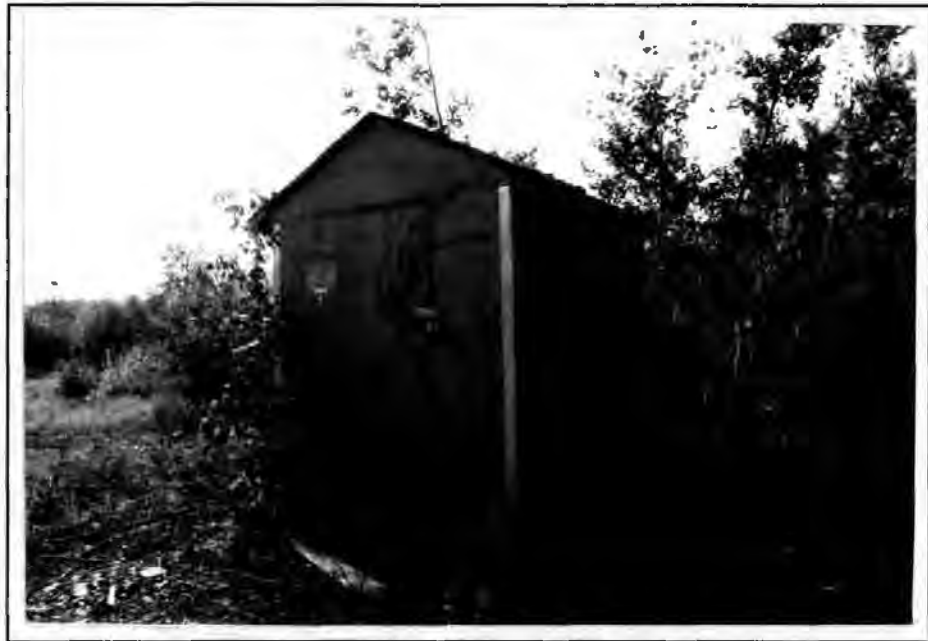
The **BLM Airstrip Storage Building (IDT-148)** is a rectangular one-story, wood frame building (Figure 103). The foundation consists of logs on grade. The building measures 6'x7'10". Asphalt shingles over roofing felt cover the gable roof. The exterior walls are covered with plywood. A plywood door is centered on the north elevation.

**Figure 103. The BLM Airstrip Storage Building, 1993. The view is looking northeast.**

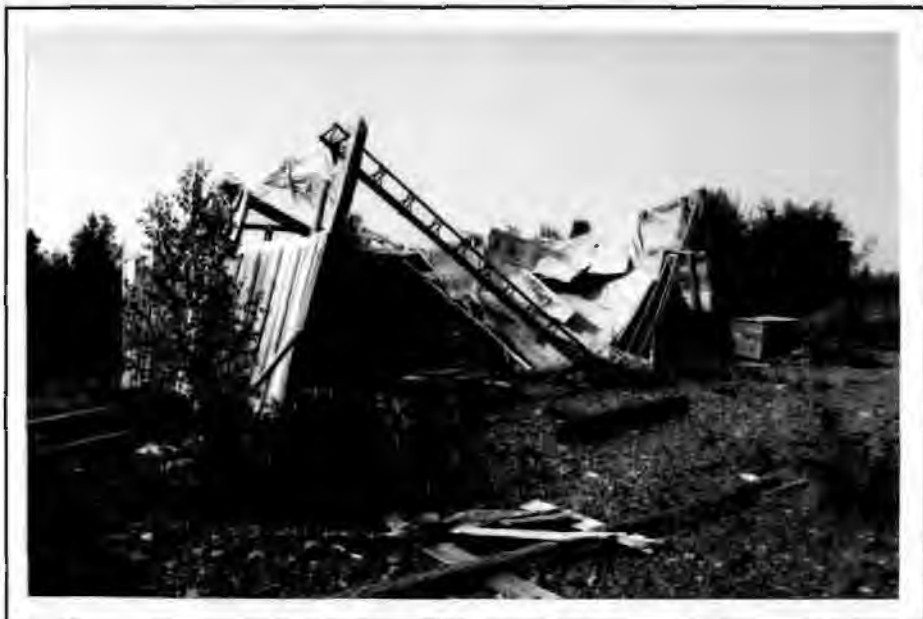
The Fullerton Hanger (IDT-149) is an irregular shaped, one-story, wood frame, collapsed building (Figure 104). The foundation is on grade. The shed roof was covered with corrugated metal. The building measures 26'7"x41'. The exterior walls are covered with wood siding, except for the north side which is open. The roof was supported in the middle by metal pipe and on the north side by a section of metal truss radio antenna from the Signal Corps facility.

John and Richard Fullerton and John Ogriz built this hanger in 1956 or 1957 of materials salvaged from local buildings and structures. The Fullertons used the hanger to maintain and shelter their airplane. The roof collapsed during the winter of 1992 or 1993 (Miscovich 1995:II-28).

**Figure 104. The Fullerton Hanger, 1993. The view is looking southwest.**

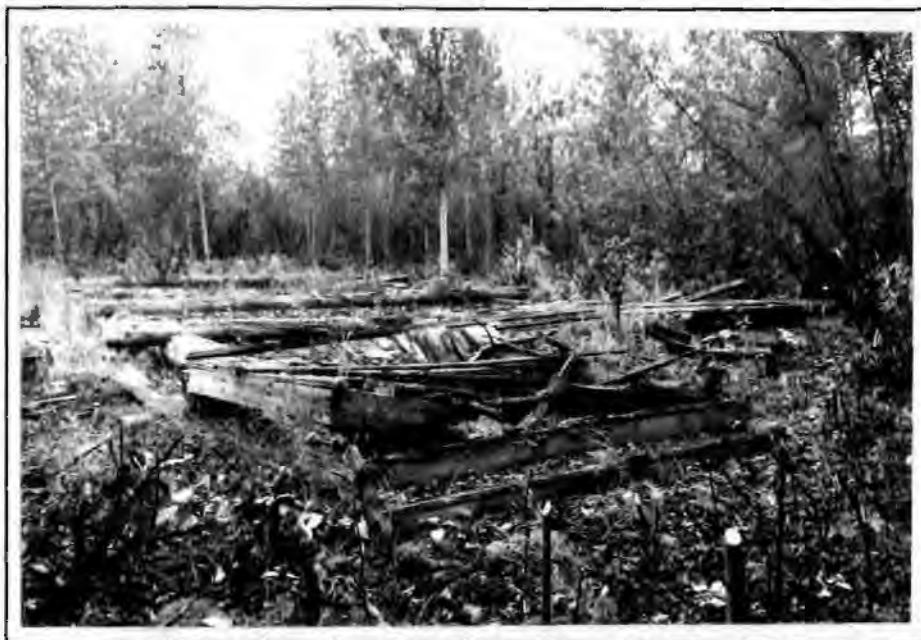
The Wadsworth House Ruins (IDT-150) consist of a log foundation measuring 25'x45', wood decking from the floor, and remnants of wood siding from the walls (Figure 106). No wall or roof sections are present in the debris. An 8'x8' set of collapsed wooden stairs is located at the south end of the east wall. Debris present at the site includes rolled roofing, linoleum scraps, bed springs, a metal bucket, and celotex. A wooden cabinet is located 14'6" south of the building ruins. A 1950s aerial photograph indicates the building was one-story with a gable roof. A shed roof addition extended the length of the west elevation.

**Figure 106. The ruins of the Wadsworth House, 1993. The view is looking west.**

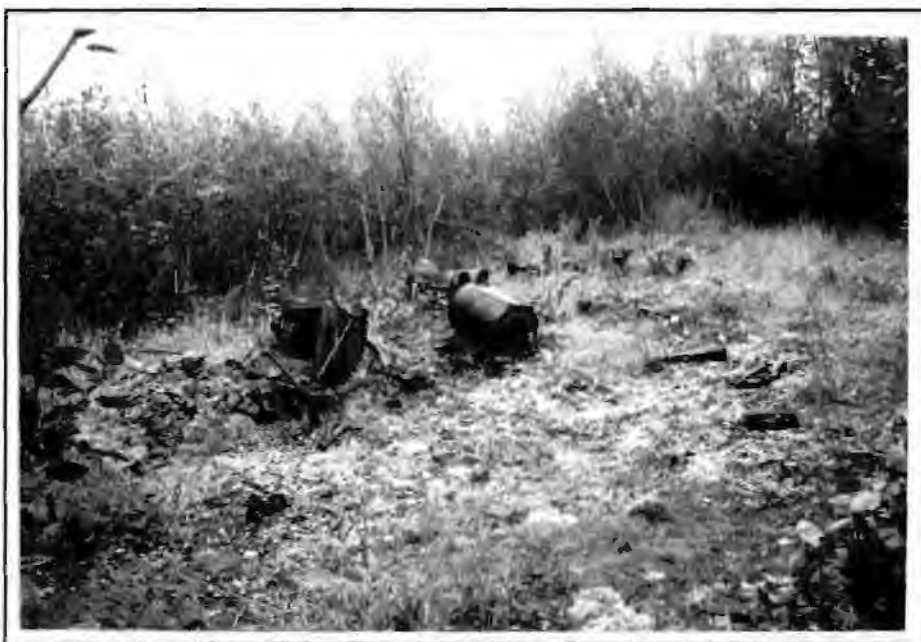
**Figure 107. The ruins of the Winters/Teddy House, 1993. The view is looking southwest.**

The Winters/Teddy House Ruins (IDT-151) are a scatter of artifacts and structural debris (Figure 107). No foundation or wall sections remain. The house covered a 20'x34' area. Artifacts and debris are scattered over an area measuring 28'x60'. Artifacts include two barrel stoves, stove pipe, fire cracked rock, a safe, a radio, bed frames, a fire extinguisher, a metal water pitcher, a can opener and lids, a bucket, a shovel blade, a metal box, a bed pan, a meat slicer made by "General Manufacturing", dishes, dinner ware ("Netherlands Universal Cambridge, made in USA"),

spoons, metal cans, broken and melted glass, ceramic fragments, a charred timber, and a sheet of corrugated metal.

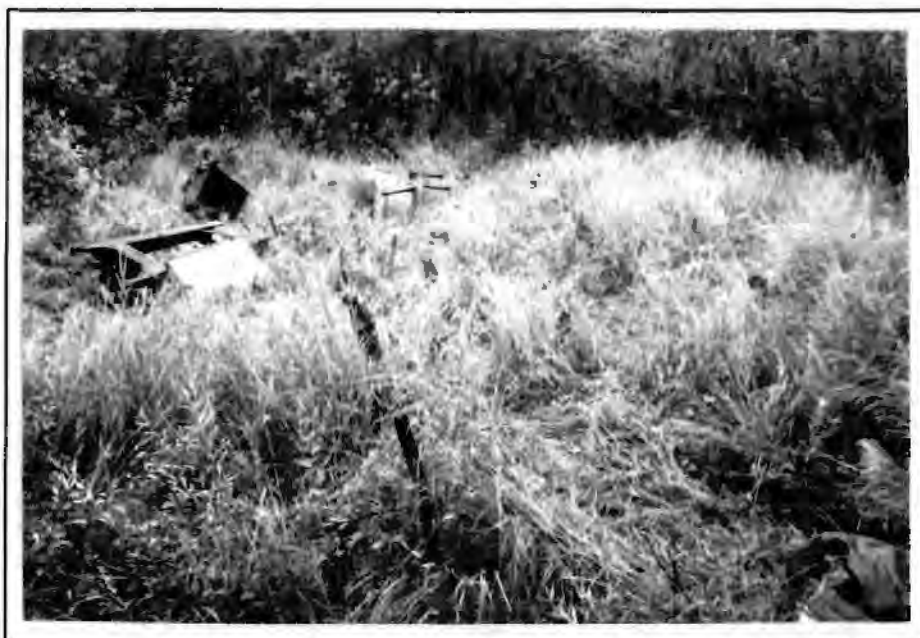
Figure 108. The Teatoff/Menzoff/Scott/Baker Cabin Site, 1993. The view is looking west.

The Teatoff/Menzoff/Scott/Baker Cabin Site (IDT-152) is the ruins of a log cabin (Figure 108) measuring 32'x35'. No roof, wall sections, or foundation are visible in the debris. Artifacts at the site include a "Trukold" oil burning refrigerator, a heater, a stove top, stove pipe, metal gas cans, a sink, and part of a metal barrel. Domestic artifacts include enamel ware, metal cans, glass jars, a coffee can, a frying pan, and a teapot. Just outside the perimeter of the house foundation is a roll of barbed wire, a sheet of corrugated metal, a rubber shoe, and several large metal cans.

The date this cabin was built is unknown. Three Russian miners, Michael Teatoff, Harry Menzoff, and Harry Scott, lived in the log cabin in the 1920s. Joe Baker lived in the building in the 1930s. Baker was an Irishman who ran card games in the cabin and sold bootleg alcohol (Miscovich 1995:IV-64; Marks

1995:145). Baker was in his nineties when he left Flat in the early 1940s for the Pioneer Home in Sitka. Bob Floyd lived in the cabin from 1946 to 1948. After Floyd died, Freddie Demientieff tore the cabin down (Agoff 1995:245, 249-250).

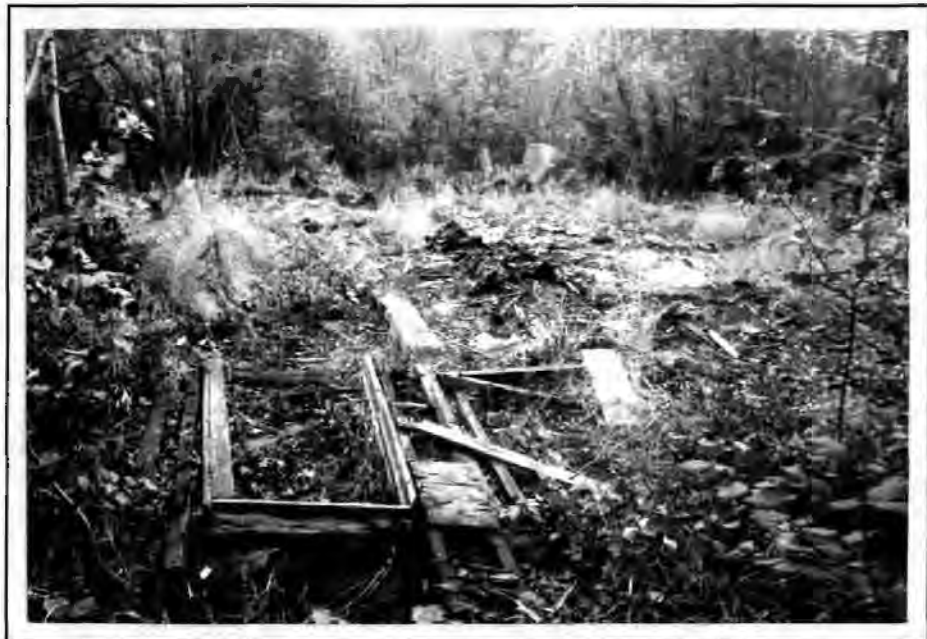
Figure 109. The Emil "Paprika" Jensen House, 1993. The view is looking north.

The Emil "Paprika" Jensen House Ruins (IDT- 153) consist of the ruins of a rectangular, one-story, wood frame building (Figure 109). The foundation consisted of logs. The building outline measures 32'4"x35'. A wall section with a door is located north of the foundation. Part of another wall section is located south of the foundation. The building had a gable roof, but no portion of the roof remains. Black and white checkered linoleum covers the floor in the north-

west corner. A record player, shoes, a mirror, a solder top can, an ice skate, bed springs, a battery, spark plugs and various domestic artifacts are present. A 1966 aerial photograph indicates that the building had a gable roof oriented north-south and a shed addition running the length of the east elevation. The aerial photograph shows that the house had four other additions but the type of roofs on the additions is not clear.

The date this house was built is not known. Emil Jensen, his Athabascan wife, and their two children, Clair and Johanna, lived in this house from 1930 until 1942. Jensen lived in Iditarod from the early or mid-1910s until 1929 or 1930, when he moved his family to Flat. He worked as a miner, a mail musher, a barge operator for Day Navigation, and for Harry Donnelley on the Riley Dredge. Jensen was from Denmark and had red hair, prompting the nickname "Paprika." The Jensen family moved to Anchorage in 1942 when World War II shut down most gold mining in the district. It is not known if the house was occupied after the war (Marks 1995:143; Miscovich 1995:IV-64).

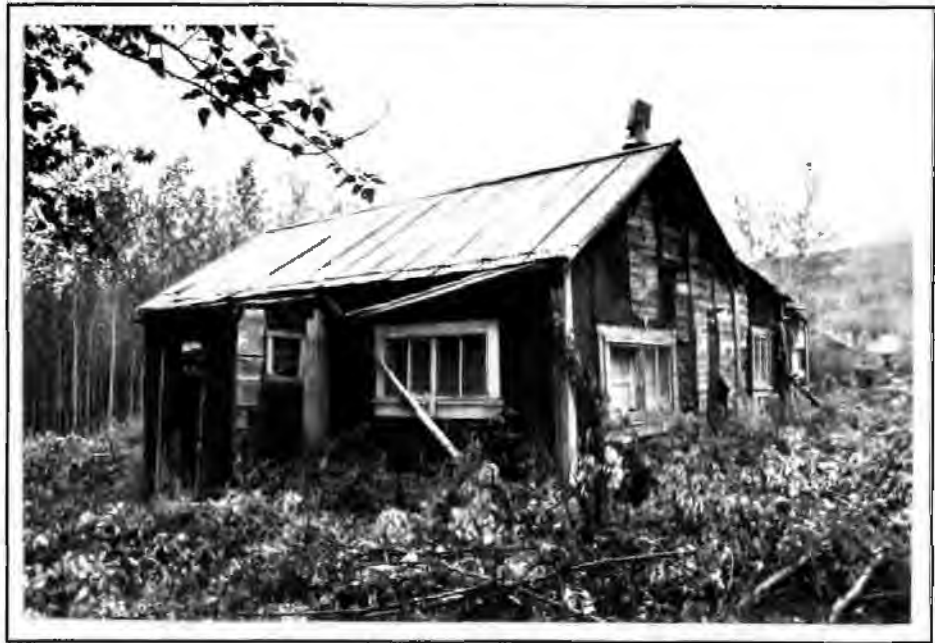
**Figure 110. The Scott/Parker House, 1993.**  
The view is looking northwest.

The Scott/Parker House (IDT-154) is a rectangular, one-story, wood frame building with three shed roof additions (Figure 110). The foundation is not visible. The gable roof and shed roofs are covered with corrugated metal. The house measures 16'x23'10". The exterior

is sided with board and batten and weathered roofing felt. The main entry is on the south elevation, which includes a pair of two-light, fixed sash windows and a shed roof arctic entry measuring 4'2"x5'11". There is a pair of two-light, fixed sash windows on the east elevation and a two-light, fixed sash window on the west elevation. The north elevation of the house has a shed roof addition measuring 9'4"x23'10". The addition has a two-

light, fixed sash window on the east elevation and a boarded up window on the west elevation. The north elevation of this addition contains an arctic entry measuring 4'5"x5'10", a two-light, fixed sash window, and a small shed addition measuring 6'5"x8'1". The arctic entry has a shed roof, a five-panel door facing north and a boarded up window facing east. The small north addition has a five-panel door on the east elevation and a four-light, fixed sash window on the west elevation. The north elevation is covered by another addition measuring 13'8"x 17'8". A short plank door is located on the east elevation, a plank door is located on the north elevation, and a boarded up window is located on the south elevation.

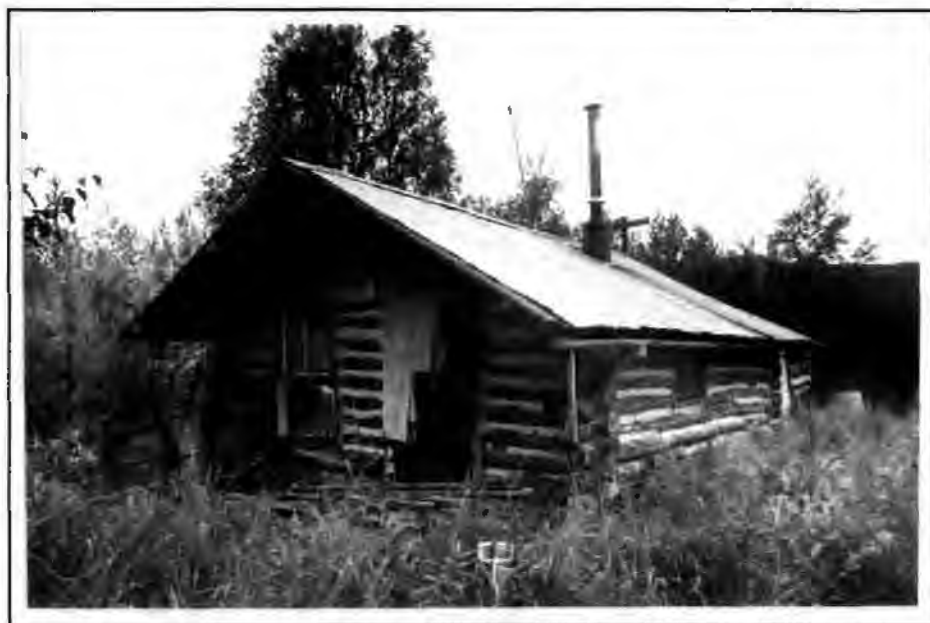
**Figure 111. The Brink/Flemings Log Cabin, 1993. The view is looking northwest.**

The **Brink/Flemings Cabin (IDT-155)** is a rectangular, one-story, log building with two wood frame additions (Figure 111). The foundation is on grade. The gable and shed roofs on the additions are covered with corrugated metal. The log building measures 16'x18'. A 2/2 single-hung window and three-panel door with one light, are located on the south elevation. A two-light, fixed sash window is centered on the west elevation and a six-light, fixed sash window is centered on the east elevation. The exterior of the two shed roof additions are covered with

rolled roofing over wood siding. The north addition measures 10'1"x16'. The addition has a pair of four-light, fixed sash windows on the east elevation and a six-light, fixed sash window covered with corrugated metal on the north elevation. A small addition measuring 4'5"x5'7" is located on the west side of the north addition. The west addition has a small window opening facing south that is covered with transparent plastic. The ruins of a collapsed wood frame outhouse is located 6' west of the west addition.

The date that Brink/Flemings Cabin was built and its original location are unknown. The ground under the building has not been dredged. The site where the cabin is located was originally used to cut wood as there is a lot of old sawdust on the site. Harry Brink moved the cabin to this location in the 1920s. Harry Brink, a miner, and his wife Minnie lived in the cabin from the 1920s to the 1950s. In the late 1930s, Brink moved a frame building (IDT-156) next door to the east of the log cabin. He and his wife lived in the frame building and he used the log cabin for a storage building. Minnie Brink sold the cabin to Jimmy and Shawn Flemings in the mid-1970s. They later sold it to Glen Johnson (Agoff 1995:243; Miscovich 1995:IV-61; Fullerton 1995: 114; Kepler 1995:129; Marks 1995:245). The dates the two additions were built are unknown.

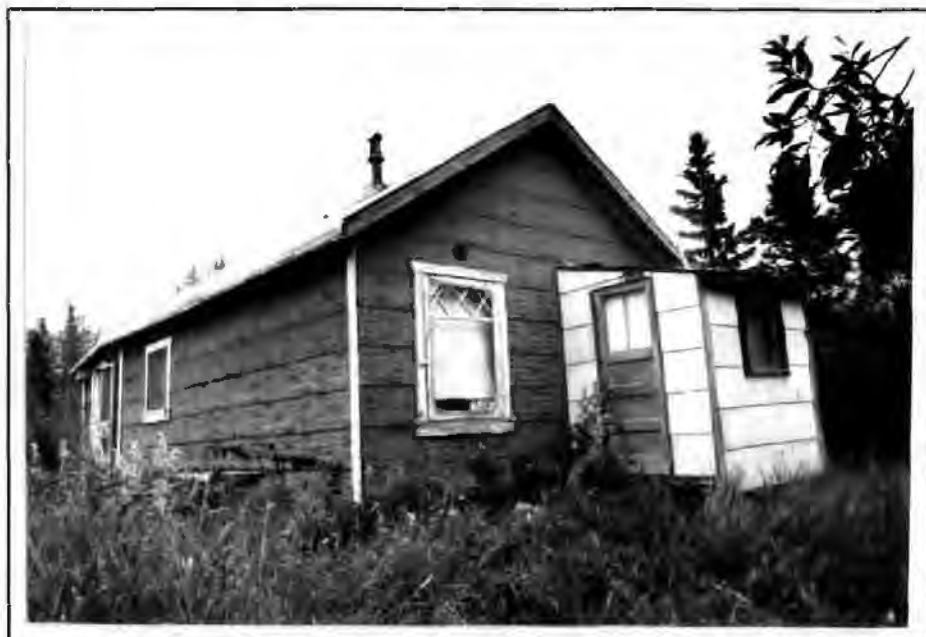
**Figure 112. The Awe/Weber/Gularte/Hubbard/Brink House, 1993. The view is looking northeast.**

The Awe/Weber/Gularte/Huhbard/Briuk House (IDT-156) is a rectangular, one-story, wood frame building (Figure 112). The foundation is timbers on grade and corrugated metal covers the gable roof. The building measures 17'x23'8". The exterior is covered with asphalt shingles. The main entry is on the north elevation, which includes a two-light, fixed sash decorative window with diamond lights in the upper light and an arctic entry. The arctic entry, which measures 5'10"x7'4", has a shed roof covered with corrugated metal and wood shingles covering the exterior walls. The south elevation of the arctic entry has a single-light window and the west elevation has a three-panel door with one light. The west elevation of the house has a single-light, fixed sash window and the east elevation has a single-light, fixed sash window and a decorative two-light, fixed sash window in which the upper light has ten diamond lights. A shed roof addition on the north elevation of the house measures 8'3"x17'. Corrugated metal

covers the roof of the addition and asphalt shingles cover the exterior walls. A one-light, fixed sash window is on the north elevation of the addition and a five-panel door is on the west elevation. A shed roof addition measuring 8'5"x9' is located on the east side of the north addition. Corrugated metal covers the roof and roofing felt covers the exterior walls. A single-light, fixed sash window is located on the north elevation and a six-light, fixed sash window is located on the east elevation.

The date this building was constructed and its original location are unknown. The earliest known location was on the south side of Otter Creek just north of the Mutchler/Hard/Uotila/Awe Blacksmith Shop (IDT-098). Fritz Awe used the building as the office for the Awe Mining Company. Later, miner Ed Weber occupied the house. Tony Gularte lived in the building when it was next to the Blacksmith Shop. Wayne Hubbard, an accountant, bought the building and moved it to south Flat near the Finn Annie/Burns House (IDT-128). Harry Brink bought the building and moved it to its present location on the north side of Otter Creek in the late 1930s. Brink and his wife lived in the building in the 1940s. Other occupants of the building included a Mrs. Carter and Mr. and Mrs. McVey. Minnie Brink sold the building in the early 1970s to Jim Flemings Sr., who replaced the foundation. Flemings later sold it to Glen Johnson (Agoff 1995:243; Miscovich 1995:IV-61-62; Fullerton 1995:114-115; Marks 1995:145).

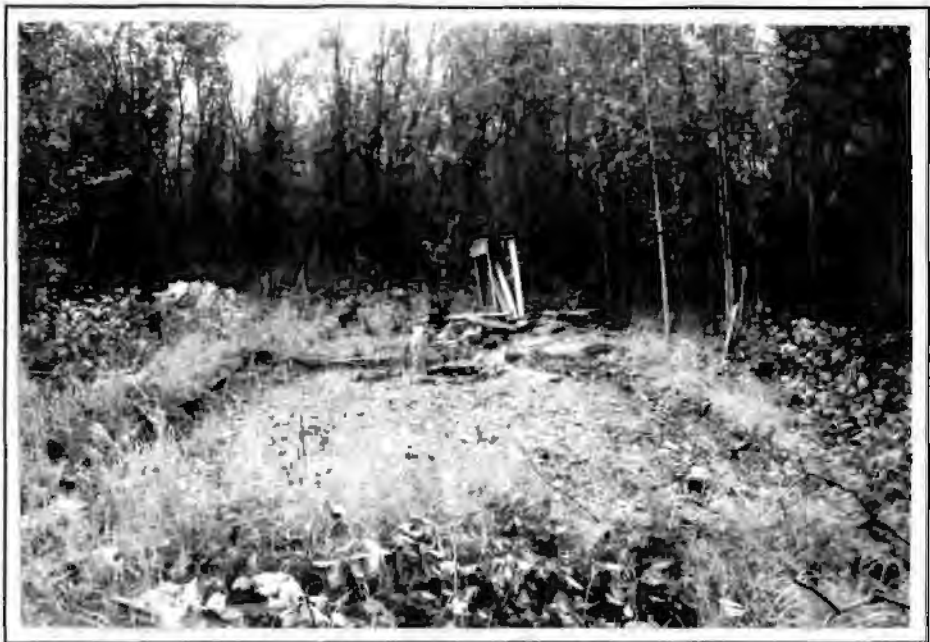
**Figure 113.** The Marshall/Loranger/Norman House Site, 1993. The view is looking south.

The **Marshall/Loranger/Norman House Site (IDT-157)** consists of a gravel foundation, structural debris and artifacts from a building that once stood at the site (Figure 113). The gravel foundation measures 15'x18'2". A pile of artifacts and structural debris, including a broom, a five-panel door, logs, wood siding, a metal hucket and a wooden box are located at the south-west corner of the foundation. Another pile of debris, including metal barrels and lumber, is located in a small clearing 9' west of the foundation. A third scatter of debris, including a collapsed wooden dog house, window frames, a screen door frame, a broken table, a wooden bench, and wooden siding, is located about 30' southeast of the foundation.

The **Marshall/Loranger/Norman Garage (IDT-158)** used to be located on this site. The building was constructed at another, unknown site in the late 1910s or early 1920s. It was

moved to this site in the 1920s. Patty Marshall, a miner, lived in the building in the 1920s and 1930s. Joe Loranger lived in the house in later years. Loranger moved into Joe Cummings' old cabin (IDT-159) in 1962 or 1963 and sold his old house to Ernie Norman. Norman widened the doorway and built a ramp so he could store his snow track machine. In the early 1990s, Ray Stock moved the building from this site to its present location 300' to the northeast (Miscovich 1995:IV-65-66; Agoff 1995:250).

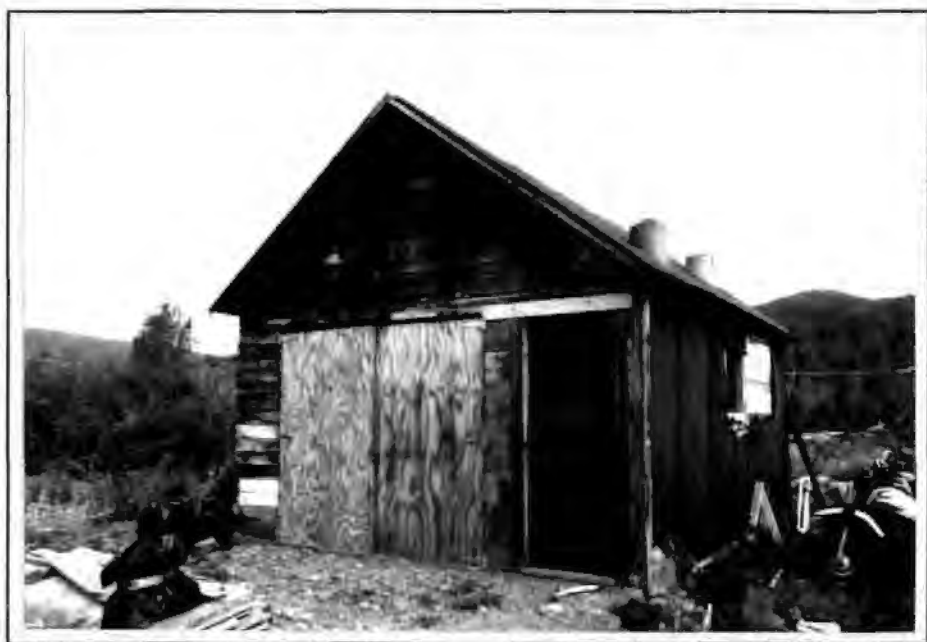
**Figure 114.** The Marshall/Loranger/Norman Garage Building, 1993. The view is looking northwest.

The Marshall/Loranger/Norman Garage (IDT-158) is a rectangular, one-story, wood frame building (Figure 114). The foundation is on grade. Corrugated metal covers the gable roof. The garage measures 14'6"x18'. The exterior walls are covered with roofing felt over shiplap. The main entry is on the south elevation, which has a pair of large plywood utility doors. A three-panel door with one light is located on the east

side of the utility doors. A single-light, fixed sash window is centered on the east elevation. A door on the north side of the building has been covered over with roofing felt.

The date and location where this building was constructed are unknown. It was moved to the Marshall/Loranger/Norman House Site (IDT-157) in the 1920s. Patty Marshall lived in the building in the 1920s and 1930s and Joe Loranger lived in the building from the 1940s to the early 1960s. Ernie Norman purchased the building from Loranger about 1962 or 1963 and converted it into a garage for his snow track machine. Ray Stock moved the building to its present location in the early 1990s (Agoff 1995:250; Miscovich 1995:IV-65-66).

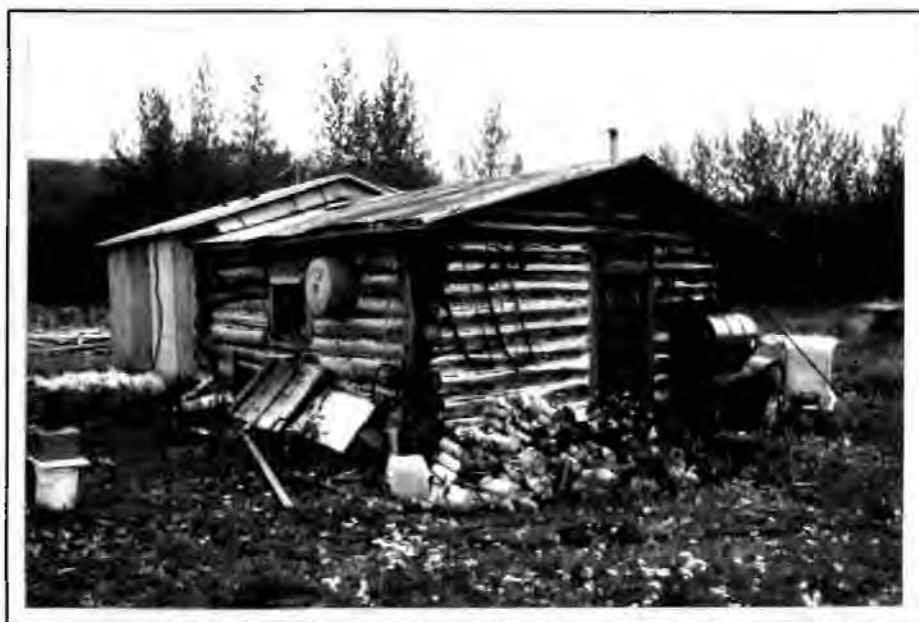
**Figure 115. The Cummings/Popavich/Loranger Cabin, 1993. The view is looking northeast.**

The **Cummings/Popavich/Loranger Cabin (IDT-159)** is a rectangular, one-story log building (Figure 115). The foundation consists of logs on grade. Corrugated metal covers the gable roof. The building measures 15'9"x17'8" and the exterior is made of logs. The main entry is on the south elevation, which has a five-panel door. A six-light, fixed sash window is centered on the west elevation. A pair of two-light, fixed sash windows are centered on the east elevation. A gable roof addition on the north elevation measures 16'1"x16'3". Corrugated metal covers the roof and the exterior is covered with plywood. A single-light, fixed sash window is located on the north elevation of the addition.

from 1912 until 1957. Cummings moved the cabin to its present location about 1946 when the Matheson Dredge came through west Flat. John Popovich, another miner, lived in the house for a short time. Long-time Flat resident Joe Loranger lived in the cabin in the 1960s. After Loranger left, the cabin was vacant for several decades. John Miscovich acquired it and has been letting Ray Stock, a retired engineer and the former city manager of Bethel, use the cabin since the early 1990s. Ray Stock built the addition on the north side of the cabin. The gable roof storage building dates to the 1910s or 1920s. Joe Cummings used it as a dog barn when he lived in the cabin. In recent years, the shed has been used for storage (Agoff 1995:248-249, 250; Miscovich 1995: IV-63, 65-66).

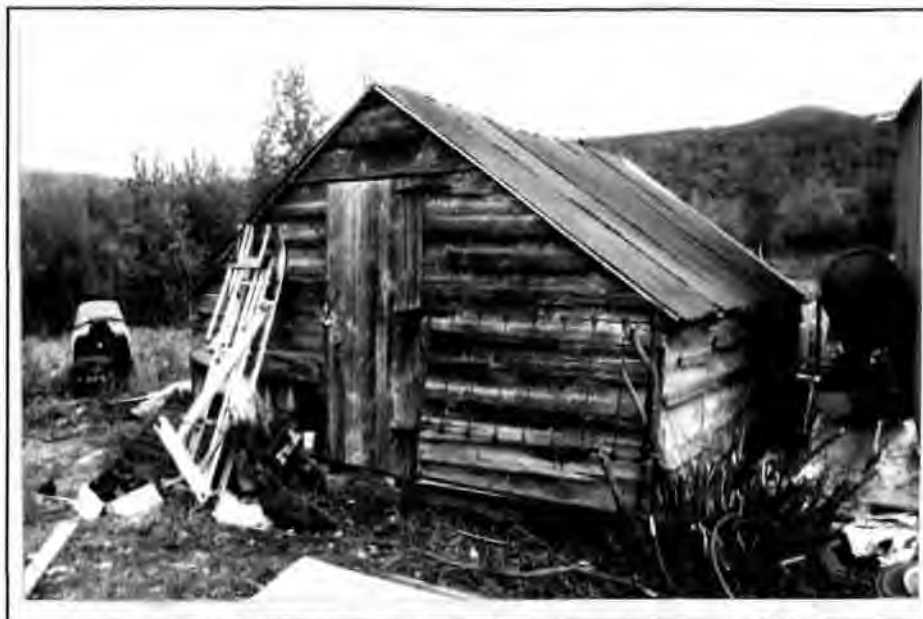
**Figure 116. The Cummings Dog Barn, 1993.**  
The view is looking northwest.

A rectangular, one-story, wood frame storage building is located 20' west of the log cabin (Figure 116). The foundation is wood blocks on grade. Corrugated metal covers the gable roof. The building measures 12'3"x 14'2". The exterior is covered with shiplap siding. A plank door is located on the south elevation. The Marshall/Norman Garage is located 12' to the south-west. A modern shed roof storage building is located between the cabin and the gable roof shed. The new shed measures 8'6"x 12'6". The exterior and roof are covered with aluminum siding and the only door faces south.

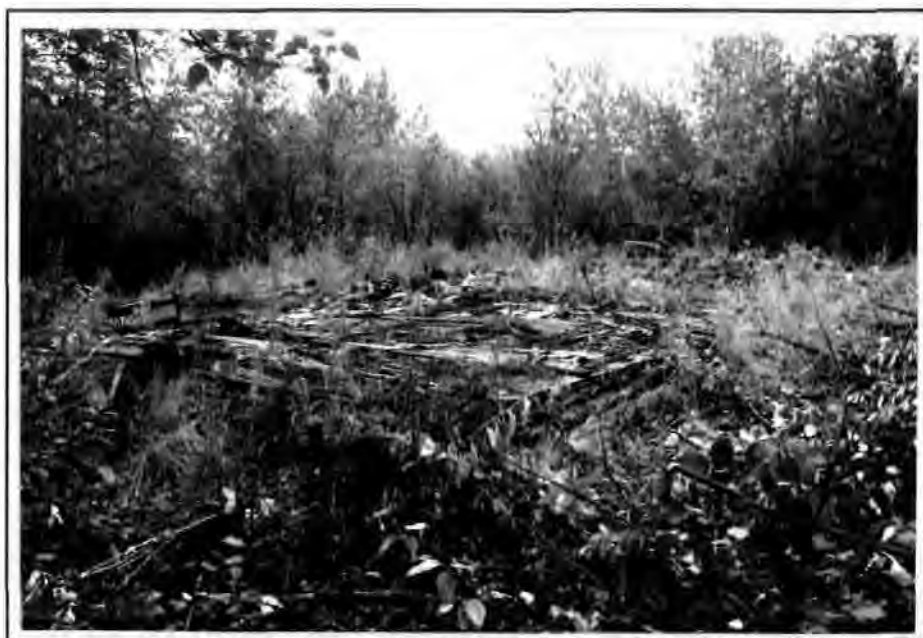
**Figure 117. The Finn Annie/Billie Harding House ruins, 1993.** The view is looking northeast.

The ruins of the **Finn Annie/Billie Harding House Ruins (IDT-160)** consist of a log foundation and tongue and groove flooring (Figure 117). The roof and walls are missing. The foundation measures 20'6"x41'6". The

foundation of an addition measuring 14'x16' is located on the east end of the north elevation. Aerial photos of Flat taken in 1966 and 1976 show a large structure with three gables at this location. A cot frame and springs are laying in the foundation. Parts of the building and artifacts located outside of the foundation include a five-panel door, a four-light, fixed sash window frame, a heater, and bed posts.

The date this building was constructed is unknown. Finn Annie lived in the house in the 1920s. After she married Lon French, the Signal Corps operator, in the late 1920s, she left Flat. Billie Harding lived in the house during the 1930s and early 1940s. Harding shared the house in the late 1930s with Jean Downey, who came to Flat from Ophir. Downey died in 1941 at the age of 36, and Harding left Flat shortly thereafter. The building was abandoned after Harding left. Shawn and Jimmy Flemings salvaged the lumber from the roof and the walls (Miscovich 1995:IV-63, 65; Fullerton 1995: 118-119; Marks 1995:145; Agoff 1995, 208, 247-248).

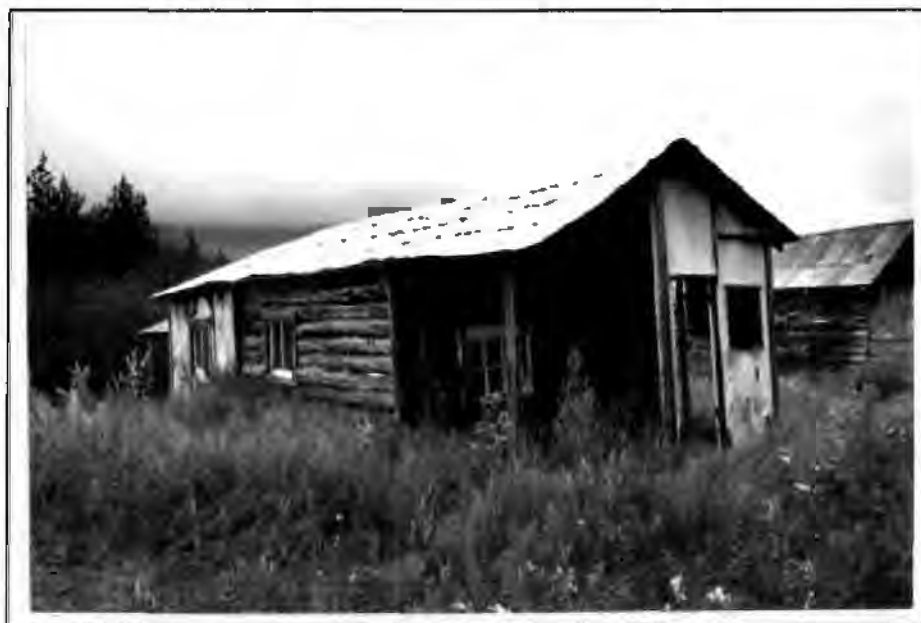
**Figure 118. The Jensen/Miller/Stuver Cabin, 1993. The view is looking northeast.**

The **Jensen/Miller/Stuver Cabin (IDT-161)** is a rectangular, one-story, log building (Figure 118). The foundation is not visible. Sheet metal covers the gable roof. The cabin measures 13'x15'. The walls are made of logs with open trough corner treatment. The main entry is on the south elevation, which has a six-light, fixed sash window and a five-panel door. A gable roof porch covers the south facade. The east half of the porch is an enclosed arctic entry measuring 6'6"x6'7". The exterior walls of the enclosed porch are covered with celotex. The west half of the porch is open. A two-light, fixed sash window is centered in the east and west elevations of the cabin. A one-story addition with a gable roof is located on the north end of the cabin. The addition measures 10'8"x 13' and the roof is covered with corrugated metal. Celotex covers the exterior walls. A two-light, fixed sash window is centered on the east and west elevations of the addition. Another one-story addition measuring 10'1"x14'6" is located north of this addition. Corrugated metal covers the gable roof and exterior walls. This addition has a single-light, fixed sash window centered on the north elevation and a plank door at the south end of the east elevation.

A gable roof dog barn measuring 11'2"x12'6" is located about 40' west of the cabin. The foundation is on grade and the gable roof is covered with corrugated metal. The exterior is covered with horizontal wood siding. A door opening and a window opening are located on the south elevation. A boarded up window is located on the east and west elevations. An outhouse measuring 4'x5' is located 29' west of the storage building. The shed roof and exterior are covered with corrugated metal over decking. The doorway faces south and a four-panel door is on the ground just south of the structure.

The Jensen/Miller/Stuver cabin was constructed in Iditarod in the 1910s or 1920s. Emil Jensen took the cabin apart and moved the logs to Flat in the late 1920s. When he reassembled the building, he cut off the notched ends and nailed 2"x10"s to the ends of the wall sections. It is not clear if he lived in the cabin. The Louis Miller family lived in it during 1936-1937 (Marks 1995:144). Joe and Jule Stuver resided in the cabin in the late 1930s and 1940s. Jule Stuver and Johnny Stevens jointly owned the cabin and they did extensive renovations on the building in 1944. Chuck Weiser came to Flat about 1957 and lived in the cabin. After several years, he acquired it from Stuver and Stevens. Shawn and Jimmy Flemings acquired the cabin in the 1970s and added the additions. John Miscovich currently owns the cabin and shed (Agoff 1995:246-247; Miscovich 1995:IV-63).

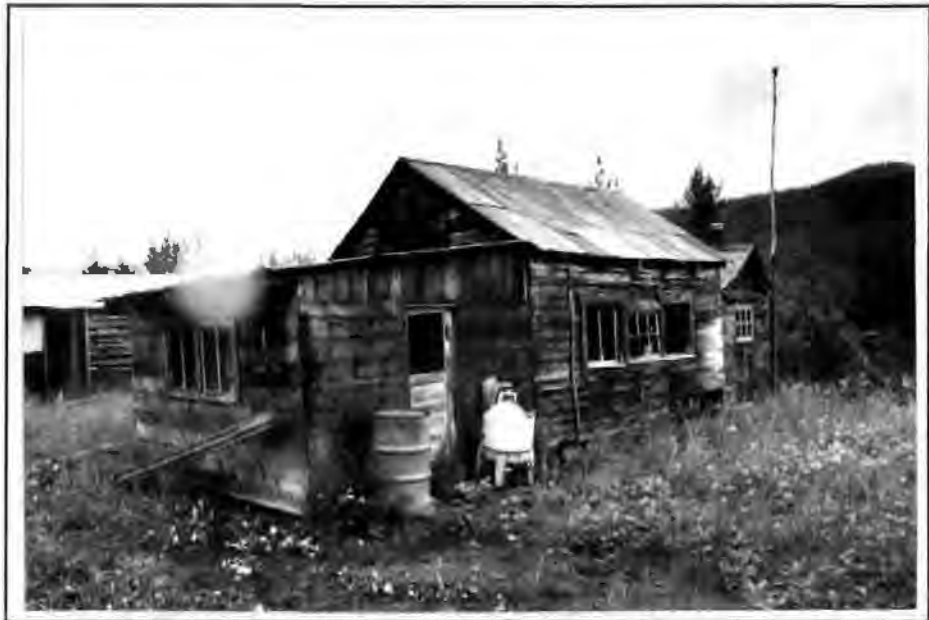
Figure 119. The Stuver Shop/Shawn Flemings House, 1993. The view is looking northwest.

The Stuver Shop/Shawn Flemings House (IDT-162) is a rectangular, one-story, wood frame building (Figure 119). The foundation is logs on grade. Corrugated metal covers the gable roof, which is oriented north-south. The building measures 14'2"x16'. The exterior walls are covered with shiplap. A six-light, fixed sash window is centered on the west elevation. Three fixed sash windows, including a two-light, a six-light, and a single-light, are located on the east elevation. A shed addition measuring 10'7"x14'2" is located on the south elevation. Corrugated metal covers the roof. The exterior walls are covered with horizontal and vertical wood siding. A pair of two-light, fixed sash windows are centered on the south elevation. A one-light, fixed sash window is centered on the west elevation and

a three-panel door with one light is centered on the east elevation. A one-story, wood frame addition measuring 7'4"x13'4" is located on the north side of the building. The gable roof is covered with corrugated metal and is oriented east-west. The exterior is covered with horizontal wood siding. A plank door covered with roofing felt is centered on the west elevation. A three-light, fixed sash window is centered on the north elevation and a six-light, fixed sash window is centered on the east elevation.
